INSPECTION CONDITIONS

Tuscany Home Inspections, LLC. Inspector Steve Haldeman Certificate #41253 Phone 623-293-7143.

January 24, 2011.

ABC lane.

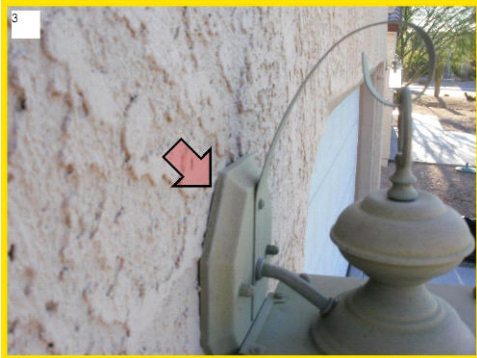
3.JPG

Cracks noted. Repairs needed, such as at: SW fascia (picture 5). Caulk/sealing is needed, such as at: Wall mounted light fixtures (picture 3), around combustion vent at East garage wall as can be seen from water marks on drywall and at gaps between weep screed and concrete slab, such as at SW area (picture 6). Note: soffit vent is displaced at NW area. Recommend further evaluation and corrections by a qualified and competent contractor.

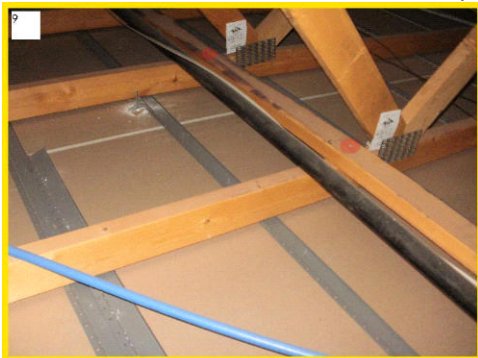
9.JPG

Truss framing in tact as far as visible. No walk boards are provided. No stains were seen to indicate leakage. Ventilation is provided, soffit/eaves area, gable, roof top. Truss bracing only has one nail per truss- Picture 9 (some have no nails).

Truss bracing only has one nail per truss- Picture 9 (some have no nails). There is what appears to be a soft water loop present. Sink is in tact with functional drainage and flow.

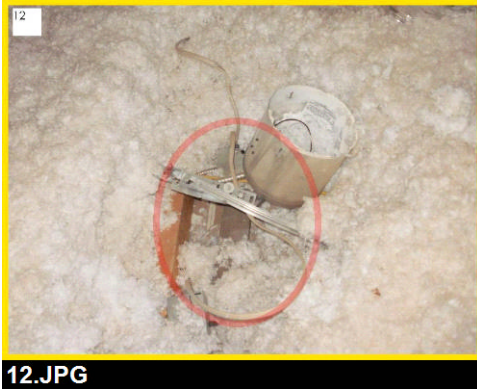
Fiberglass- Blown. Over all depth of insulation is adequate. Insulation is displaced, such as over living room where light has been replaced(picture 12).

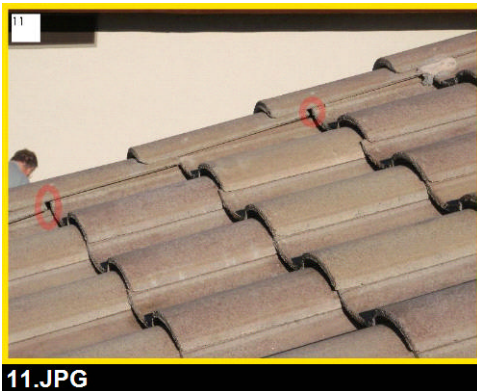
Over all condition of roof is adequate as far as visible. Open areas at roof edges are not fully sealed, such as at West end (picture 11). One area has been "mud balled" in, such as at the top of the picture. A qualified and competent roofing contractor should be called to make further evaluation and repairs as needed.

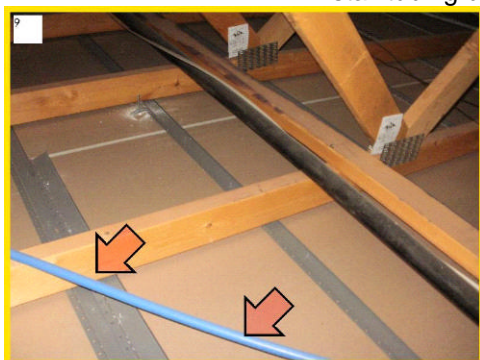
9.JPG

Functional flow is adequate. Lines not fully visible. Pex lines are not covered with insulation, such as over garage(picture 9). Wirsbo pex manual states: "Caution: When installing in attics, install tubing below the insulation to protect from excessive heat or cold."

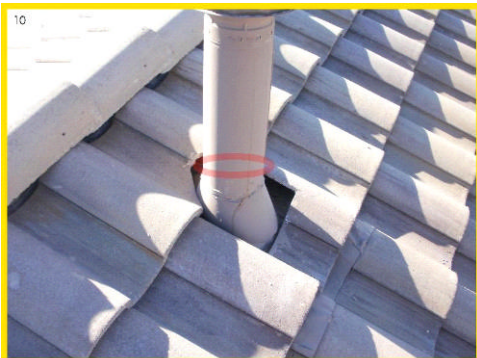
10.JPG

Metal. Appears serviceable over all. Storm collar is missing from water heater/furnace flue (picture 10). A qualified and competent roofing contractor should be called to make further evaluation and repairs as needed.

Unit is producing hot water. Pressure relief valve noted, not tested. Follow manufacturers instructions. A water shutoff valve is installed. Not tested. Flue vent is present, however, roof top is missing the storm collar (picture 10) and flue is displaced at the draft hood (picture 7). Recommend further evaluation and any corrections by qualified and competent plumber.

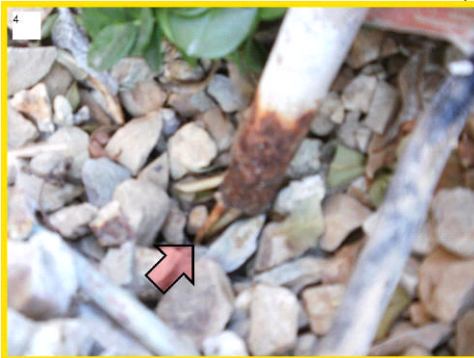
4.JPG

Copper. Aluminum (220 volt OK), Romex. Unsafe conditions exist, such as at fountain conduit (picture 4). Wires are without the benefit of underground rated conduit. Light appears to have been replaced over living room (picture 12).

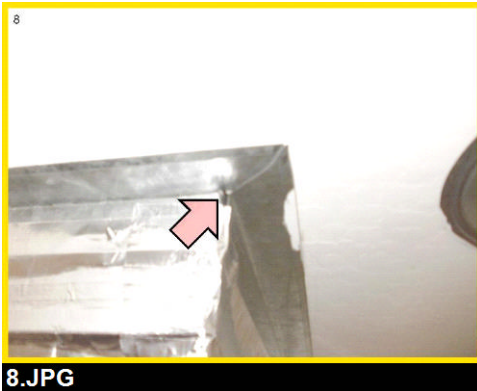
Air leaks noted- Sealing is recommended, such as at garage(picture 8).

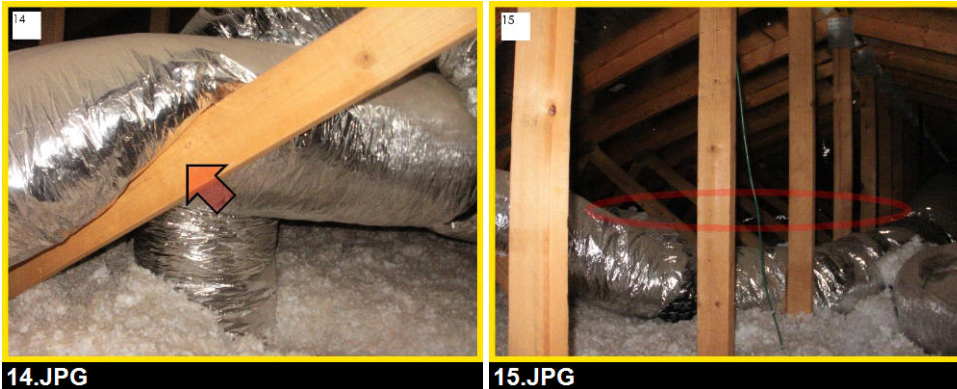
Flexible Round. Excessive sags/bend/dips/restrictions noted, such as at West end(pictures 14 and 15).

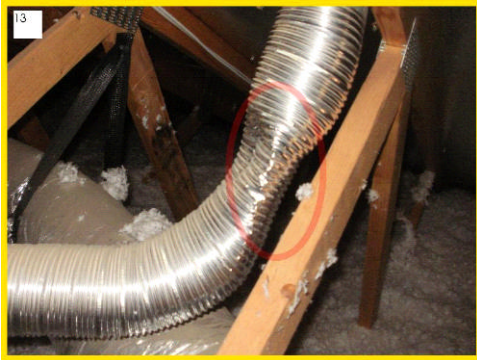
13.JPG

Prefabricated metal. Gas supply. Damper is operational. Fireplace was found to be operational. Combustion air vent is damaged (picture 13). Recommend further evaluation and corrections by qualified and competent fireplace contractor.

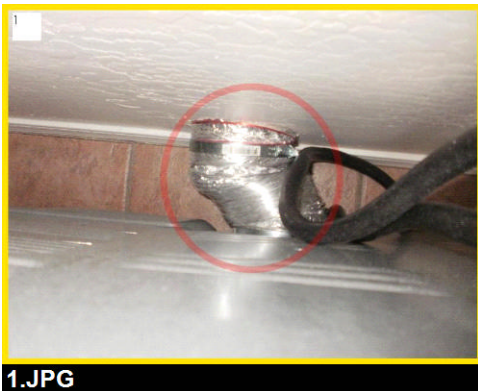
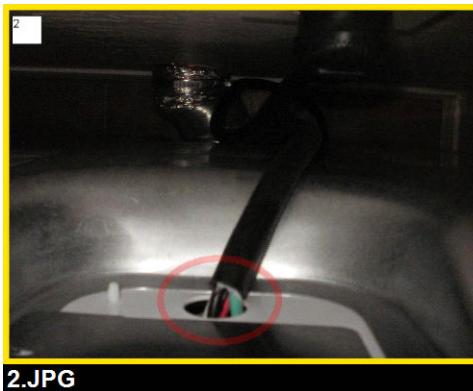
Electric. Functional. Dryer vent is foil. Although some builders and appliance manufacturers may allow this, we routinely recommend this be changed to a rigid or semi rigid metal to increase safety(picture 1). Wiring is displaced and missing connector at rear as well(picture 2). Recommend further evaluation and corrections by a qualified and competent appliance contractor/technician.
