RE: ABC Lane
Surprise, AZ 85374

SUMMARY OF AREAS REQUIRING FURTHER EVALUATION

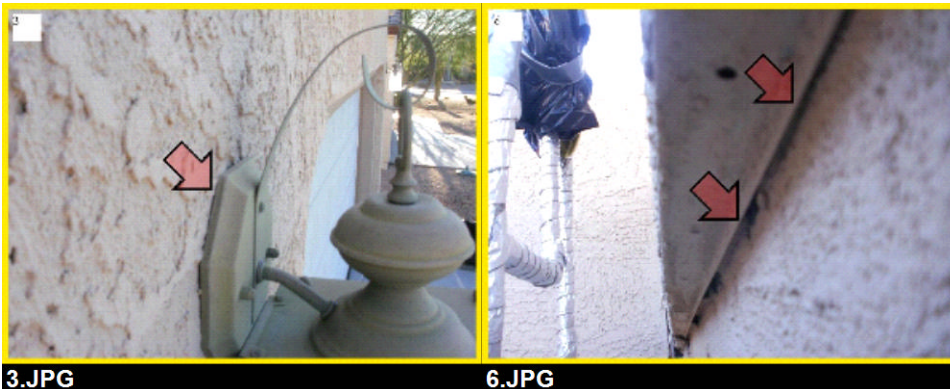
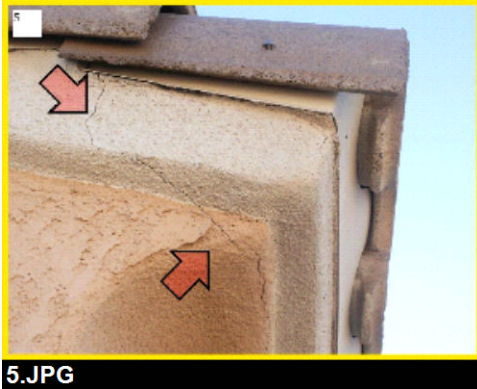
1. Cracks noted. Repairs needed, such as at: SW fascia(picture 5). Caulk/sealing is needed, such as at: Wall mounted light fixtures(picture 3), around combustion vent at East garage wall as can be seen from water marks on drywall and at gaps between weep screed and concrete slab, such as at SW area(picture 6). Note: soffit vent is displaced at NW area. Recommend further evaluation and corrections by a qualified and competent contractor.

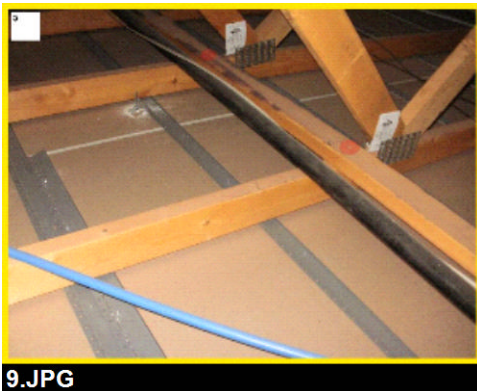
4. Truss framing in tact as far as visible. No walk boards are provided. No stains were seen to indicate leakage. Ventilation is provided, soffit/eaves area, gable, roof top. Truss bracing only has one nail per truss- Picture 9 (some have no nails).

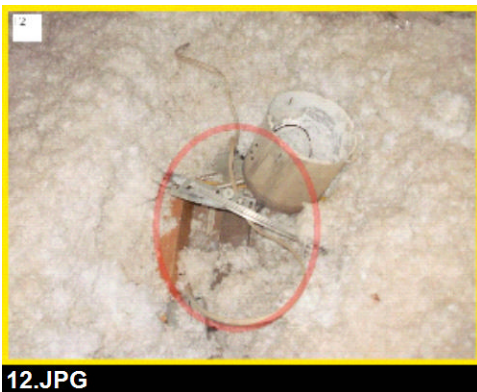
5. Fiberglass- Blown. Over all depth of insulation is adequate. Insulation is displaced, such as over living room where light has been replaced (picture 12).

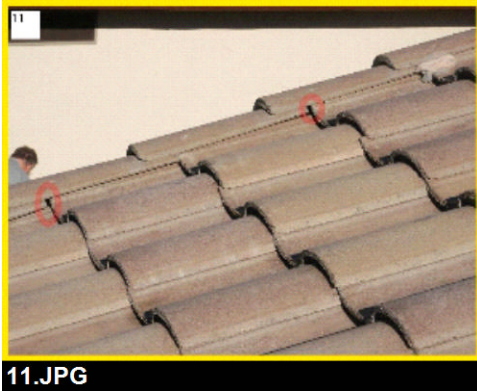
6. Over all condition of roof is adequate as far as visible. Open areas at roof edges are not fully sealed, such as at West end (picture 11). One area has been "mud balled" in, such as at the top of the picture. A qualified and competent roofing contractor should be called to make further evaluation and repairs as needed.

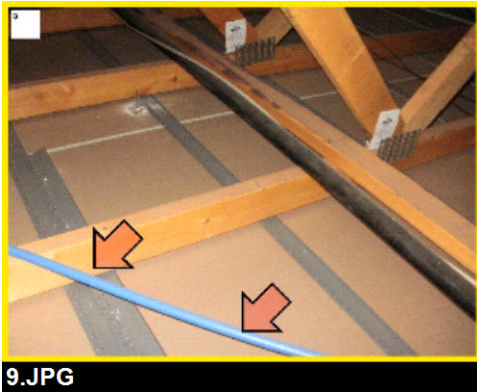
7. Pex lines are not covered with insulation, such as over garage (picture 9). Wirsbo pex manual states: "Caution: When installing in attics, install tubing below the insulation to protect from excessive heat or cold."

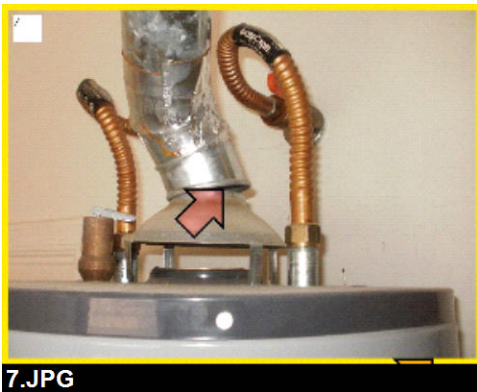
9. Flue vent is present, however, roof top is missing the storm collar (picture 10) and flue is displaced at the draft hood (picture 7). Recommend further evaluation and any corrections by qualified and competent plumber.

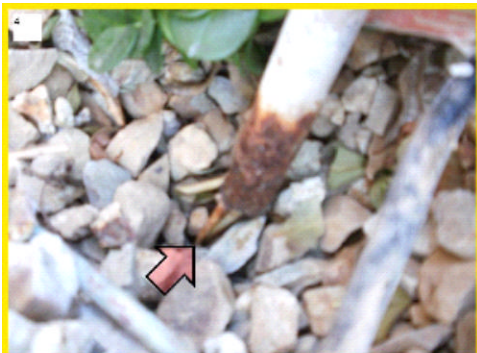
4.JPG

14. Unsafe conditions exist, such as at fountain conduit(picture 4). Wires are without the benefit of underground rated conduit. Light appears to have been replaced over living room(picture 12).

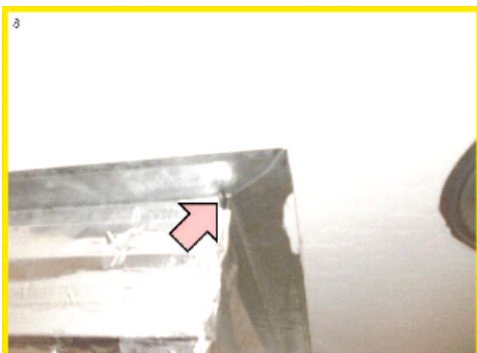
8.JPG

16. Air leaks noted- Sealing is recommended, such as at garage(picture 8).

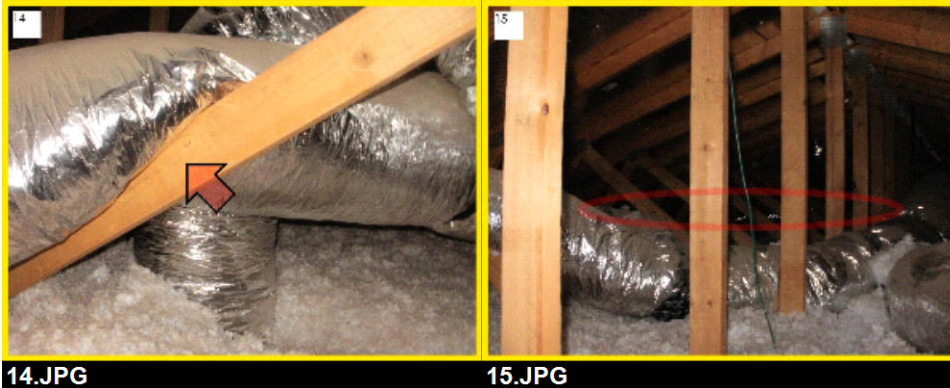
17. Flexible Round. Excessive sags/bend/dips/restrictions noted, such as at West end(pictures 14 and 15).

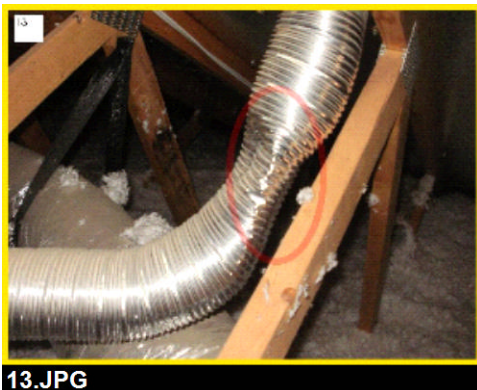
20. Combustion air vent is damaged(picture 13). Recommend further evaluation and corrections by qualified and competent fireplace contractor.

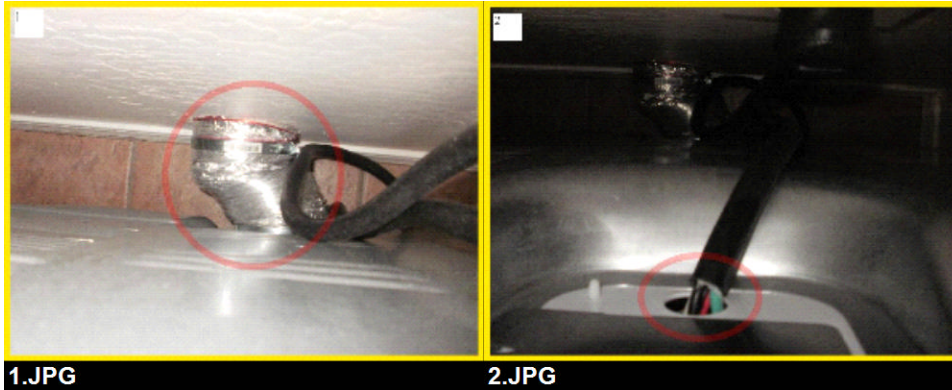
24. Electric. Functional. Dryer vent is foil. Although some builders and appliance manufacturers may allow this, we routinely recommend this be changed to a rigid or semi rigid metal to increase safety (picture 1). Wiring is displaced and missing connector at rear as well (picture 2). Recommend further evaluation and corrections by a qualified and competent appliance contractor/technician.
